Manhole Inspection Summary

Manhole # S15AA1013MH

Location Address: **3532 COTTAGE AVE**

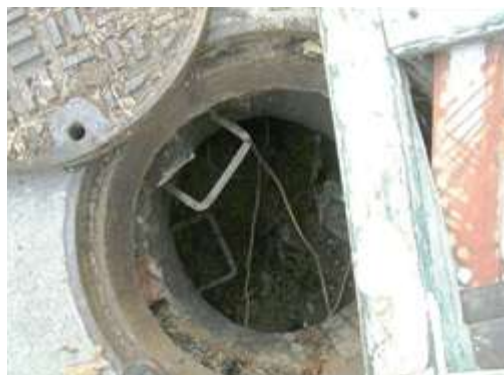
Top View

Channel debris.

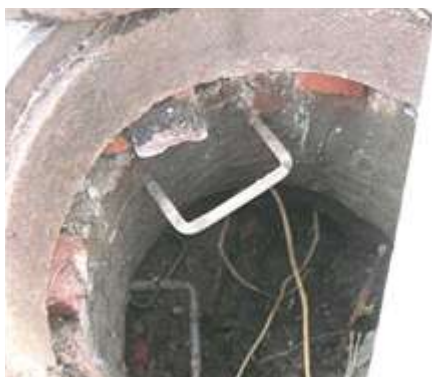
Defect

Frame leaks. Adjustment deterioration, loose brick and infiltration. Corbel root intrusion and infiltration

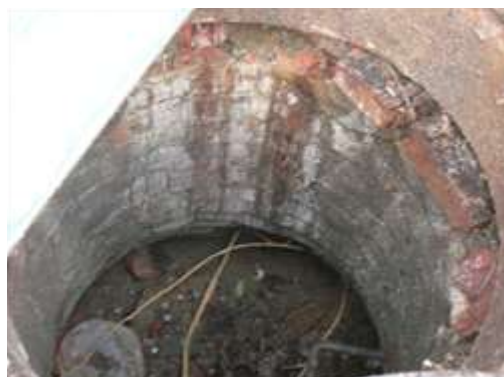
Defect

Frame leaks. Adjustment deterioration, loose brick and infiltration. Corbel root intrusion and infiltration - other side.

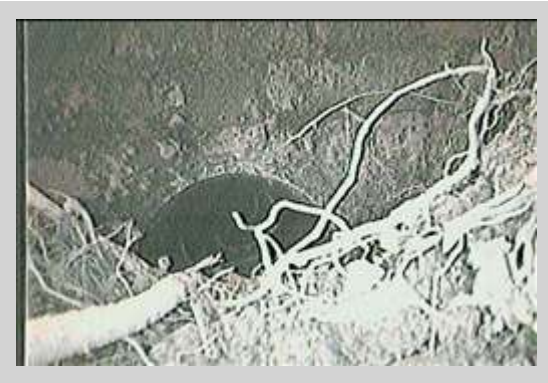
8 in. Circular Gravity Sewer Pipe Out @ 12 O'Clock

Barrel deterioration and infiltration. Channel debris.

Infiltration: **None** Pipe Seal Cond: **Cracked**

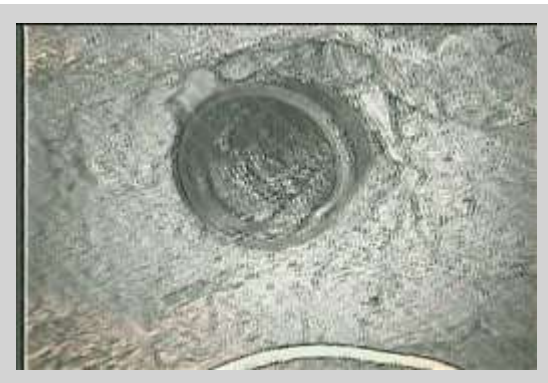
4 in. Circular Gravity Sewer Pipe In @ 6 O'Clock

Barrel cracks and infiltration.

Infiltration: **Evidence** Pipe Seal Cond: **Cracked**

☒ **Possible Illicit Connection**
